Report of the Research Institute of Industrial Technology, Nihon University
Number 68, 2003

A Study on Slope protection by Grand Anchor for the Toukai Earthquake

Takakimi Ohki* and Makoto Imano**

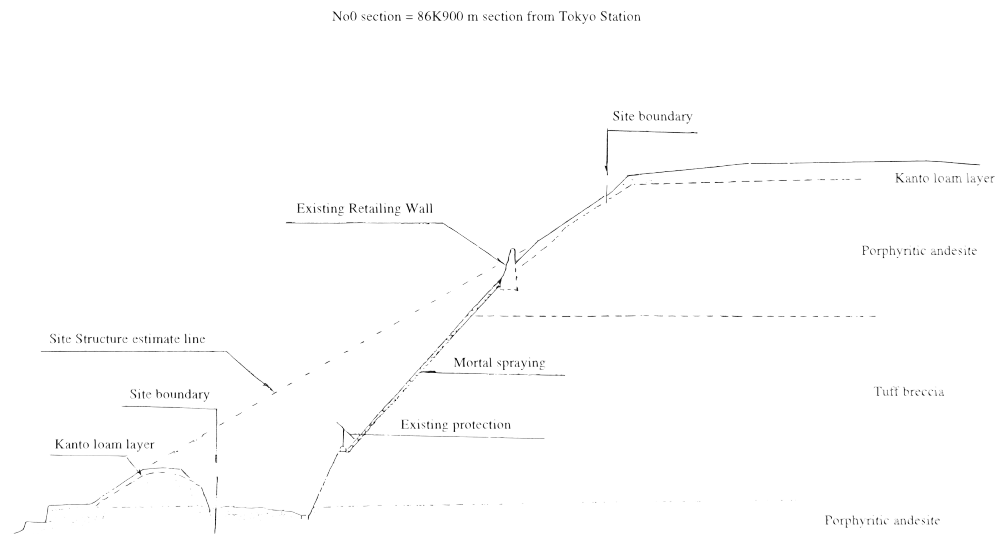
Fig.8 I block representative section

Between the No. 0-10 m and No. 0+5 m sections, the surface soil and heavily weathered layer of rock in the slope above the upper retaining wall are expected to collapse when a large-scale earthquake occurs. This collapse is considered to be small in scale, being confined to the surface layer of the slope. The margin behind the retaining wall placed above is limited. Therefore, it is readily expected that even a small-scale col-

lapse will cause fragments of rock etc. to get over this existing retaining wall. The slope below the retaining wall is steep, so a rockfall prevention fence is set up by the side of the permanent way. However, it is considered highly possible from the slope gradient and surface irregularities that the soil and cobbles getting over the existing upper retaining wall will also get over the rockfall prevention fence beside the permanent way, resulting in directly hitting the permanent way.

Even a small-scale collapse will cause the cobbles etc. getting over the existing retaining wall to directly hit the permanent way. Therefore, it is necessary to select measures to prevent collapsed soil etc. from getting over the existing retaining wall.

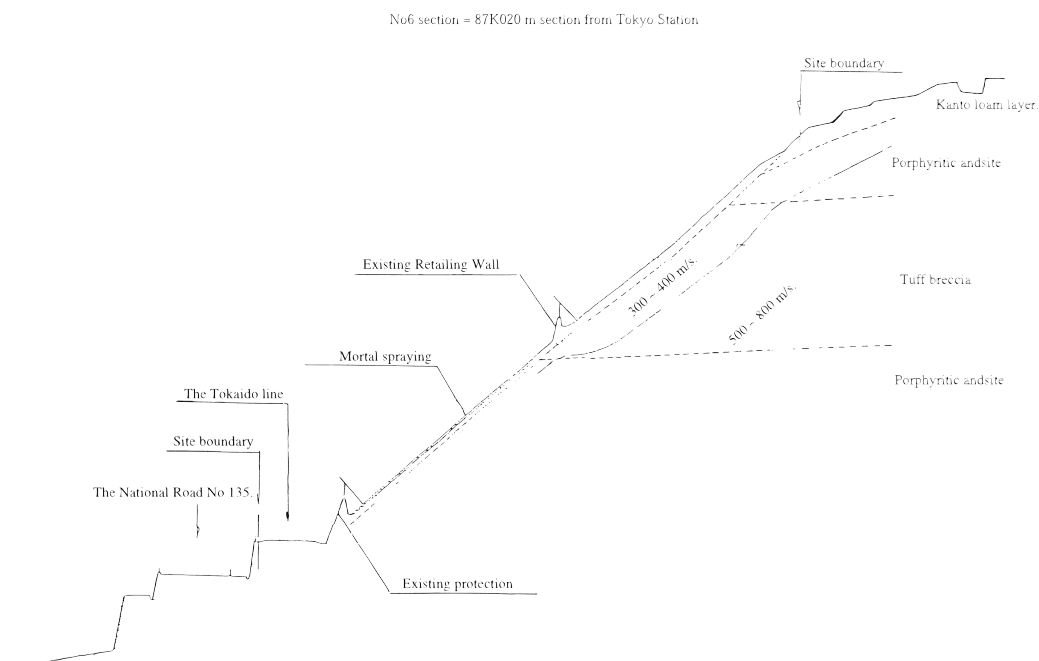
Fig.10 II block representative section

In this block, a retaining wall and a rockfall prevention fence are provided by the side of the permanent way. Between the No. 5+15 m and No. 12+16 m sections, there are a leaning type retaining wall and a mortal-sprayed surface. However, either of these slope protections is fairly old and exhibits conspicuous cracks and exfoliations. The slope is thickly wooded with trees and other vegetation.

At the elevation of about 50 m, there is a 5 m high rockfall prevention fence beneath which a retaining wall is provided. The rockfall prevention fence nearer to Tokyo from the vicinity of the No. 10+10 m section is new. The rockfall prevention fence, about 80 m long, nearer to Tokyo from the No. 6 section was constructed in March 1982.

In this upper slope, the area between the No. 5 and No. 12 sections is considered to involve a high risk of collapse. In the middle part of the slope, a rockfall protection fence (5.0 m. high) is set up. Part of the foundation of this fence is not extended to the rock layer. Therefore, it is presumed that the framework of the fence will become unstable when an earthquake occurs.

In the lower slope, the depth of collapse is estimated at about 1 m. Collapsed soil is thick between the No. 1+9 m and No. 5+15 m sections. In other parts (between No. 5+15 m and No. 12+16 m sections), surface soil is very thin. The type of collapse is surface collapse. Most of the rockfalls are from the exposed surface of the heavily weathered rock layer. Cracks and exfoliations are conspicuous on the existing slope protections. However, the existing slope protections are expected to have a certain prevention effect, so the necessity to take countermeasures for this slope is inferior in priority order to that for other slopes.

The procedure to carry out a countermeasure is as follows. That is, first remove the deteriorated parts of the existing slope protection, then remove the remainder of surface soil and finally provide the same type of protection as the former one.

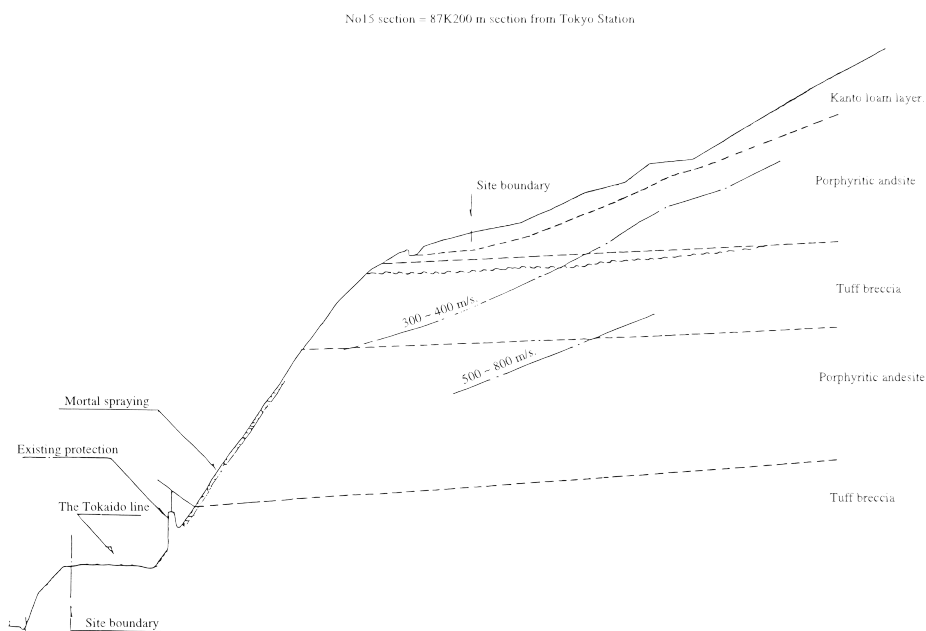
Fig.11 III block representative section

are installed as far as the middle part of the slope. A leaning type retaining wall or a concrete-sprayed surface is provided on other slopes. However, these structures are considerably deteriorated, exhibiting cracks and exfoliations.

As in the case of Block II, the rock layer corresponding to tuff breccia is expected to collapse due to weathering. In this block, the lower stratum is a little compacter than tuff breccia in Block II. The velocity value obtained by velocity logging is as high as 670 m/s, compared with the value of 480 m/s in Block I. Between the No. 14 and No. 16 sections, however, the layer of andesitic lava in the upper part is very thin. There is the possibility that the rock layer will collapse due to weathering, with the layer of 300-400 m/s velocity by velocity logging as the collapse face. When the rock layer collapses, it will be unavoidable for the permanent way to be directly hit by falling rocks.

Spring water is constantly flowing out to the two gullies in the former site of landslide in the upper part. The gullies are deeply hollowed out. Collapsed soil may become unstable due to an abnormal outflow of spring water when a local torrential rain or an earthquake takes place. Moreover, the surface layer of the lower slope is likely to collapse as in the case of Block II.

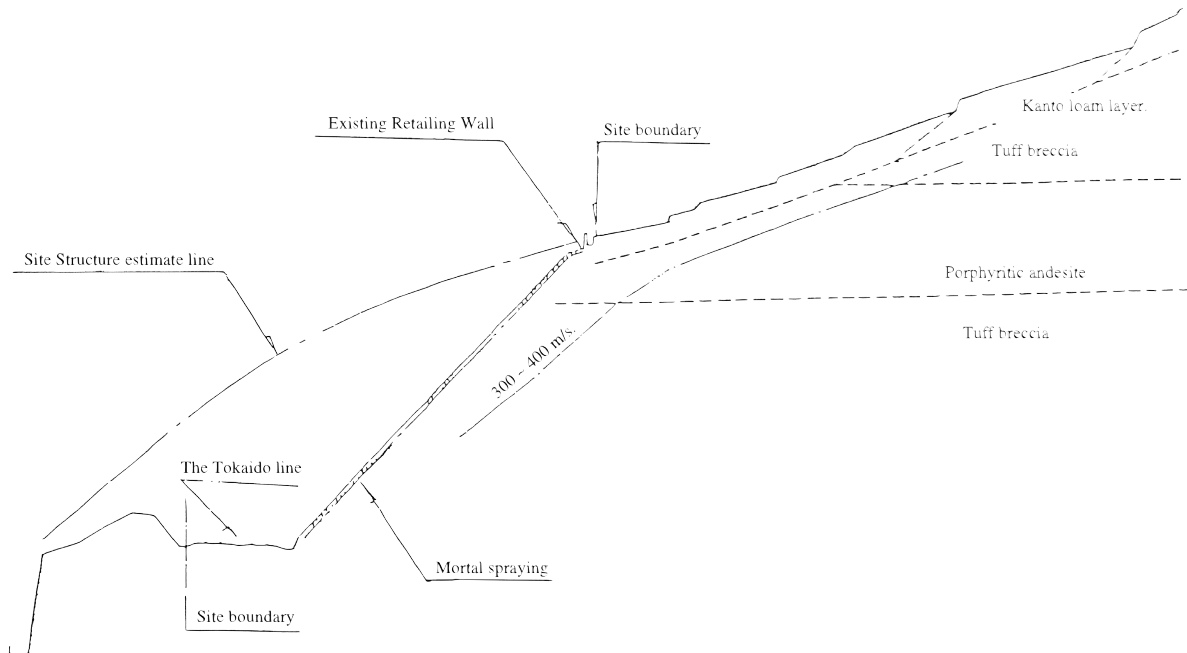
Fig.12 IV block representative section

The slope protection nearer to Block III is thickly wooded with trees and other vegetation and exhibits cracks. On the other hand, the foundation of the slope protection nearer to Block IV is extended to base rock, so this structure is stable.

The existing drainage exhibits cracks in the vicinity of the No. 18 section. The results of the observation made since several years ago has shown no abnormality. As the ground is stable, the cracks are assumed to have resulted from the deficiencies in construction.

For the reasons mentioned in **Paragraph. 4.4.2**, no disaster is likely to occur in Block IV. In view of the site conditions, a temporary catwalk should be constructed across this block at the time of providing countermeasures for other blocks. In this case, it is necessary to set up a temporary fence to protect the permanent way. This protection fence must be designed as a structure that can be made use of even after the countermeasures for other blocks are provided. This structure should serve as a protection line by the side of the permanent way in Block IV.
